Long-Term Reliability Study of Photovoltaic (PV) System Installation on Islands

APEC Energy Working Group

July 2017

APEC Project: EWG 21 2015A

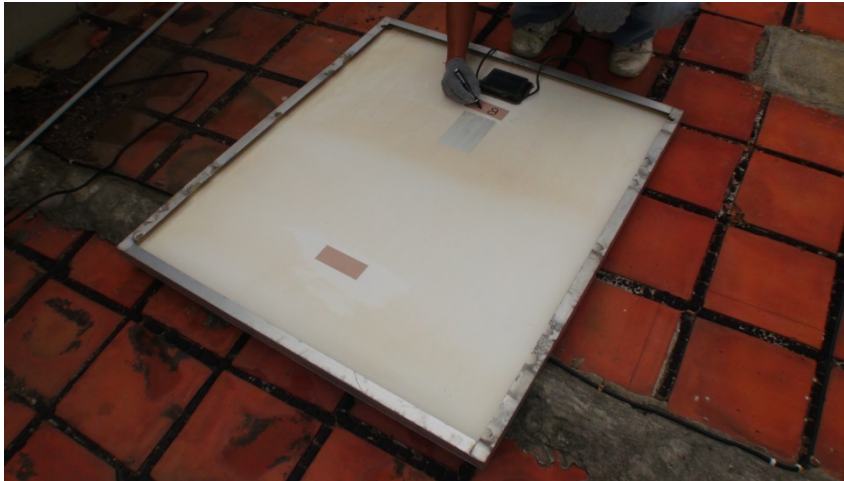
The Penghu PV system operated for 17 years under harsh environment. The aluminum frame had serious potential corrosion phenomena. When the system's parts were maintained/replaced in December 2007 to resume power output, plastic spacers were placed between aluminum frame and stainless screw to avoid potential corrosion. Figure 1.3.4 shows that the mentioned action did not really solve the potential corrosion problem. It is suspected that the sea wind and rain with salt accumulated in the aluminum frame and screw. The accumulated salt became conductive and generate potential corrosion between the aluminum frame and screw.

Figure 1.3.4 Aluminum frame with potential corrosion phenomena of the Penghu PV system

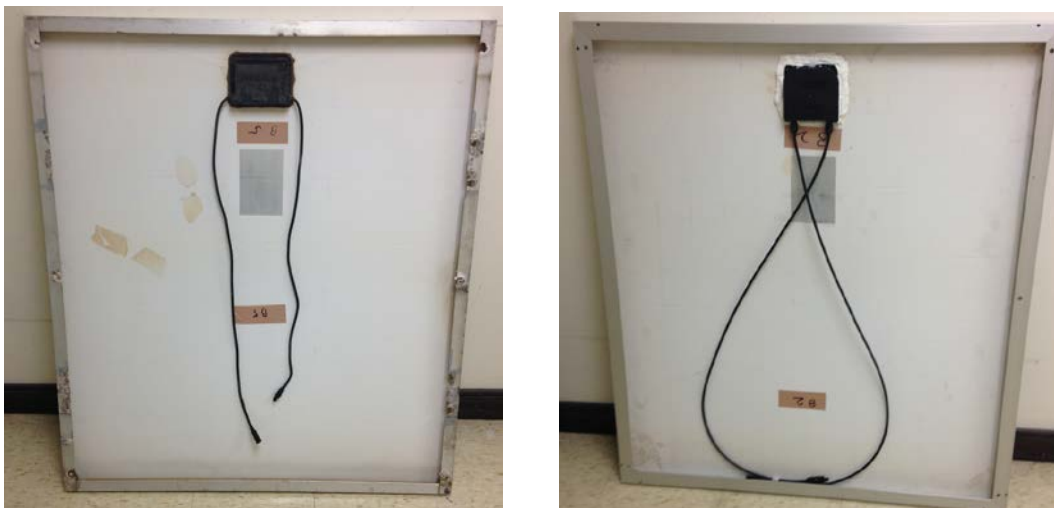
Figure 1.5.1.3.1 pre-drilled holes of aluminum frame

For the new aluminum frame, pre-drilled holes were processed before going through anodic treatment. In other words, all pre-drilled holes had anodic treatment.

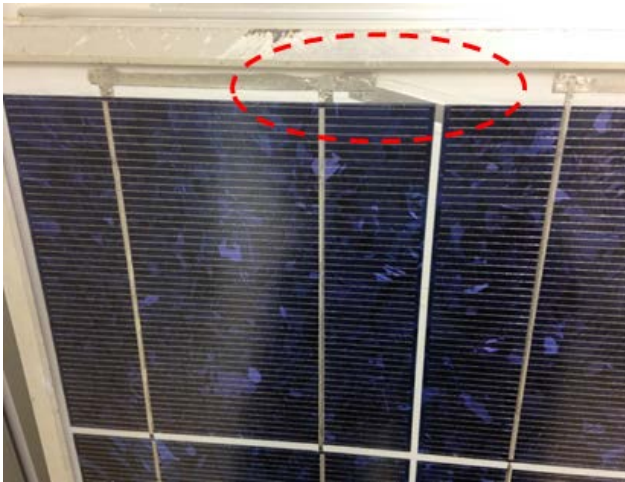
Figure 1.5.3.3.1 shows the connection position between wider ribbons. The shedding or poor connection between wider ribbons resulted in no power output or loss of one or two series solar cell power, respectively. Thirteen of 20 aging modules were damaged.

Figure 1.5.3.1.1 Shedding position of wider ribbons

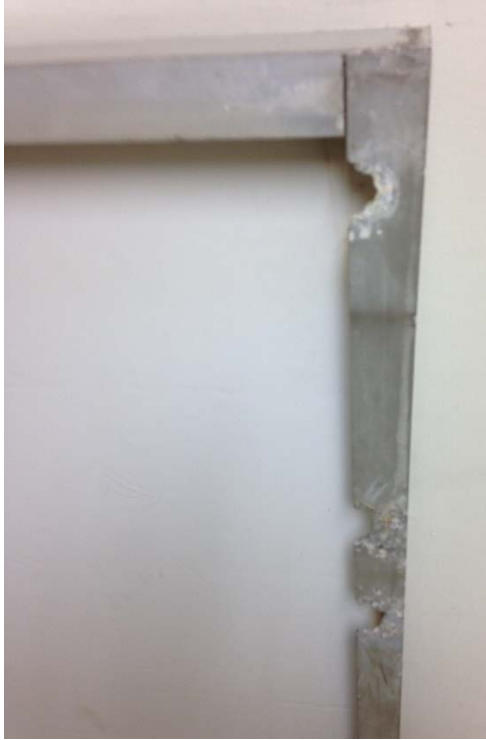
The aging Penghu PV system, built in 1999, was maintained in 2007. When the module was fixed on the system supporting structure, insulating plastic gasket ring was placed between aluminum frame and system supporting structure due to potential corrosion consideration. The gasket ring prevented electricity conductivity between stainless screws and aluminum frame. Conductivity results in potential corrosion phenomenon. After analyzing the aging PV module, it is found that all 20 modules' screw positions show potential corrosion. Some assemble holes even had completely collapsed. It is concluded that the whole aluminum frame go through anode treatment before re-assembling. During re-assembling, the frames were drilled then screwed. The drilled holes without anode treatment results in potential corrosion although gasket rings were used. It is believed that the salt in the air accumulated inside the holes, forming electric conductivity, and resulted in potential corrosion.

Figure 2.1.5.3.1 Potential corrosion of aluminum frame

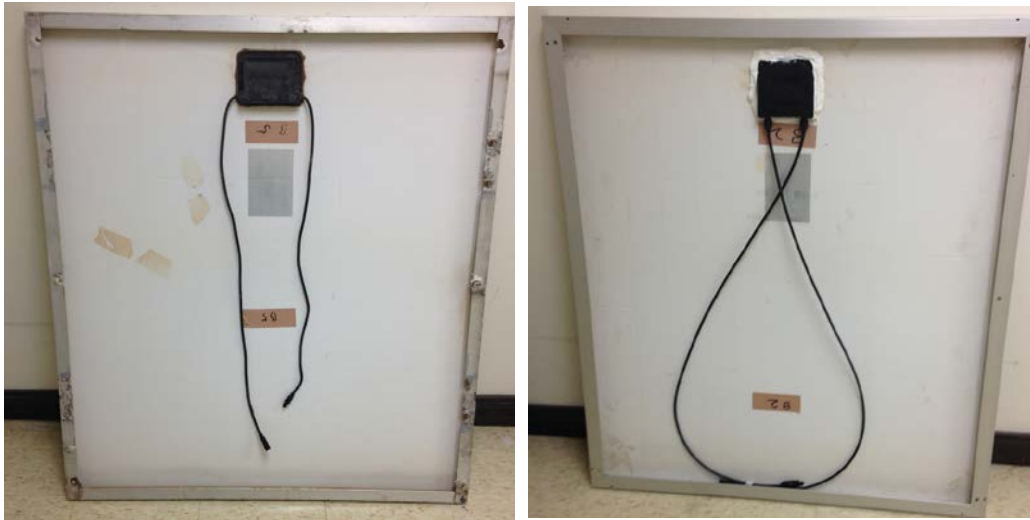
All aluminum frames were replaced, due to serious potential corrosion. Otherwise, the poor mechanical load of the modules cannot withstand gale and typhoon. All aluminum frames were drilled needed holes, before anode treatment. The procedures made sure that the frames will not have potential corrosion issues. It should be addressed that the aluminum frame must form a continuous electric path. Otherwise, the finished module will not pass EC61730-2 MST13 ground continuity test. Figure 3.1.3.2 shows the before/after maintenance of the original modules.

Figure 3.1.2.1 Maintenance of the original module

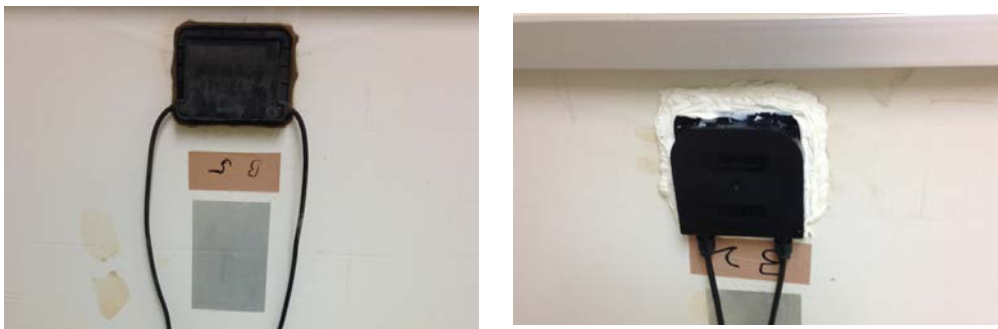
Tyco junction boxes were used to replace the existing junction boxes because diodes were burned out after long periods of operation in the harsh environment. Also, the metal elements inside the junction box's connector showed atmospheric corrosion. Since connectors connect modules, the electric properties needed to match each other. For these two reasons, the junction box had to be replaced by new Tyco junction boxes.

Figure 3.1.2.1 Junction box replacement

Left: before replacement; right: after replacement

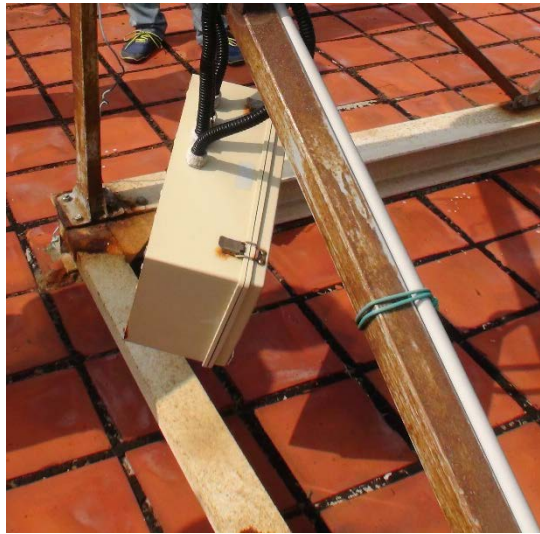
4. Because DC combiner box and DC combiner box were installed on the side of the rooftop array bracket, the connector of cable, which was near the interface of inner and outside monitor box, started corroding under harsh environment. The monitor box had fallen down because the corrosion of the screws, which were used to fixed the box. Rain, therefore, enter the monitor box and the damaged the parts.

Figure 4.1.3 Monitor box fallen down

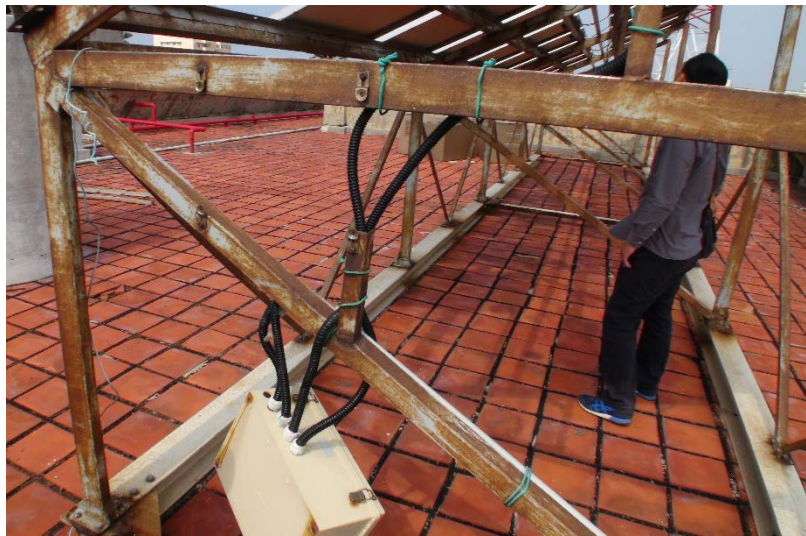
mentioned corrosive phenomena. Figure 4.1.6–7 show the contact point corrosion between bracket base, screw, nuts, and H shape stainless. Figures 4.1.8 and 4.1.9 show that the corrosive phenomena on the surface of bracket and soldering point of bracket respectively. The cover of DC cable tray was deformed and cannot be sealed completely. A lot of waterproof connector had fallen down or dismiss at the enter point of the cable tray. The surface of DC cable trays showed corrosion. The anti-UV cable, which were used in the Penghu PV system, had aging and cracking phenomena (Figure 4.1.11).

Figure 4.1.5 Corrosive phenomena on bracket

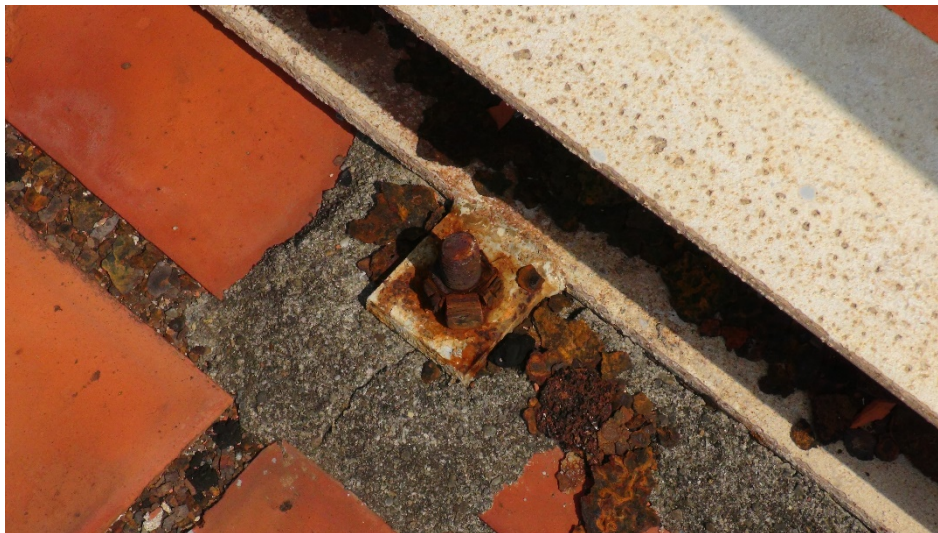
Figure 4.1.6 Status of screws and nuts

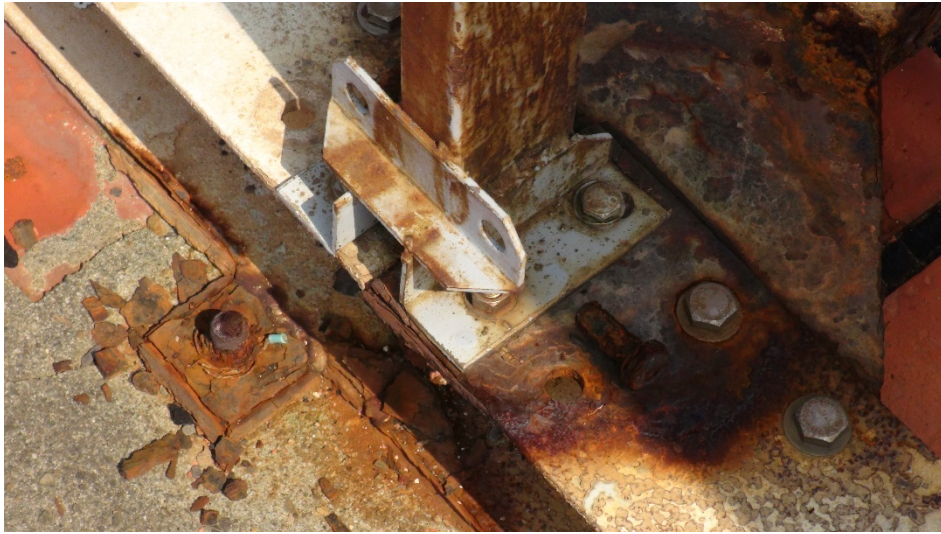
Figure 4.1.7 Contact point corrosion between bracket base, screws, nuts, and H shape stainless

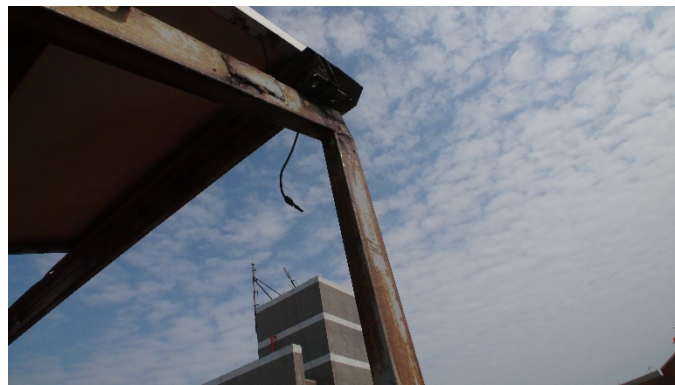
Figure 4.1.8 Corrosive phenomena on the surface of bracket

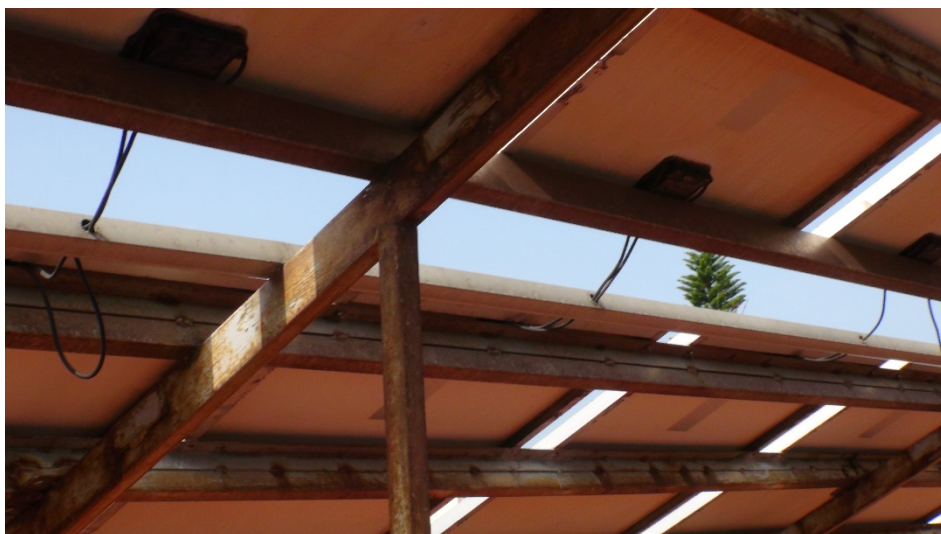
Figure 4.1.9 Corrosive phenomena on soldering point of bracket

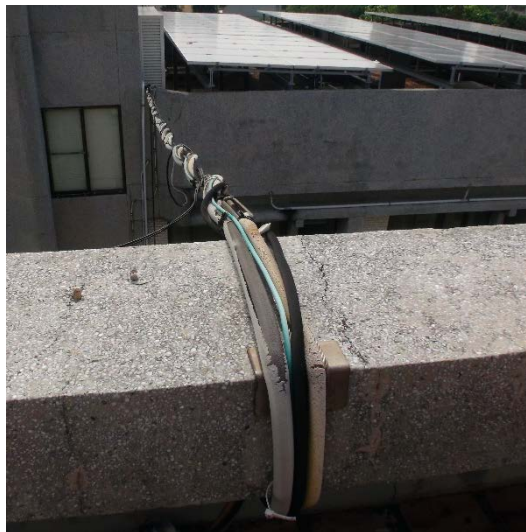
Figure 4.1.11 Anti-UV cable had aging and cracking phenomena

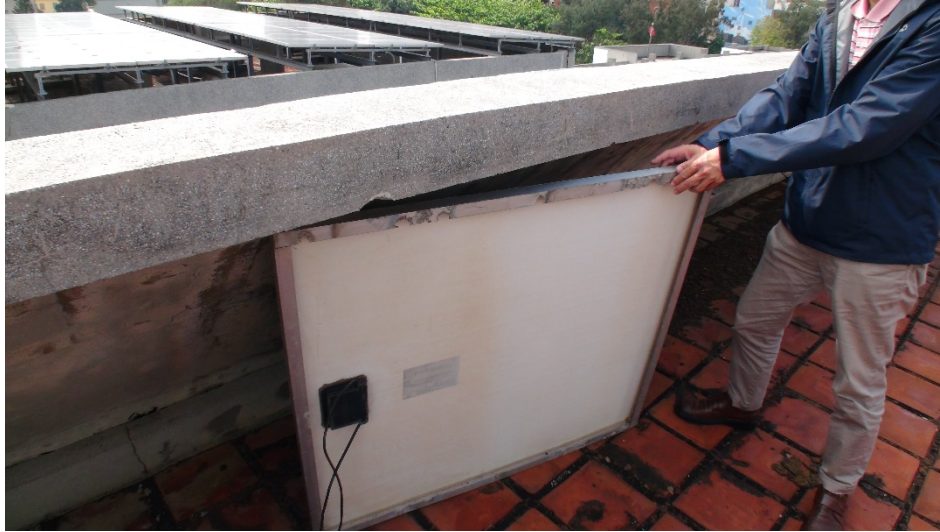
6. Some modules had fallen down during the summer typhoon season because of the corrosion of the module frame (Figure 4.1.12). The certified modules were moved back to Hsinchu laboratory for further examination to assess the status of the modules. The results were discussed in chapters 1 and 2.

Figure 4.1.12 fall down module
