Long-Term Reliability Study of Photovoltaic (PV) System Installation on Islands

APEC Energy Working Group

July 2017

APEC Project: EWG 21 2015A

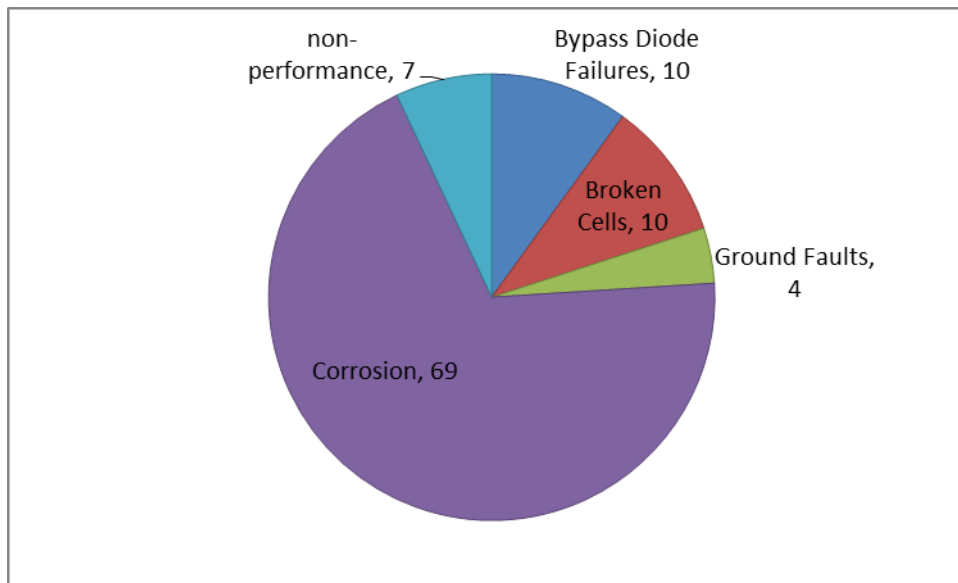
Figure 1. Failure rates after IEC 61215 Qualification Testing at Penghu islands

A list of major failure mechanisms for crystalline silicon modules at Penghu islands is given in Table 1 and failure rates as shown in Figure 1.

Failure Modes	
Bypass Diode Failures	10%
Broken Cells	10%
Ground Faults	4%
Corrosion	69%
non-performance	7%

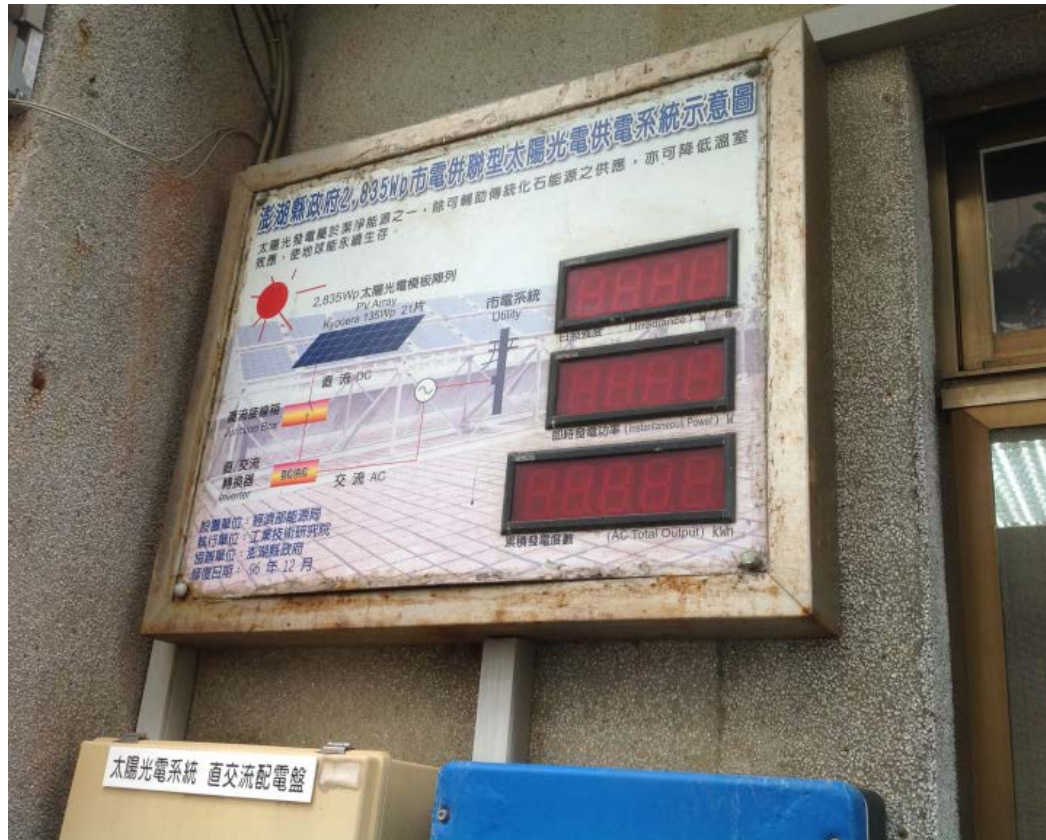
Figure 1.3.3 Monitor display of the Penghu PV system

The maintained parts were mainly PV system bracket, DC cable confluence groove and disk maintain, AC switchboard, monitor box, and inverters, etc. The system resumed power output and on grid in 2008. Figure 1.3.3 shows the monitor display of the Penghu PV system. DC combiner box was installed on the side of array bracket. AC power panel, inverter, and watt hour meter were installed. AC power panel, inverter, monitoring system, transformer, and watt hour meter, were installed on the first floor wall of the Civil Engineering department. After the large scale maintenance in 2007, the parts were used for more than 8 years. The status of the parts warrant further researching.

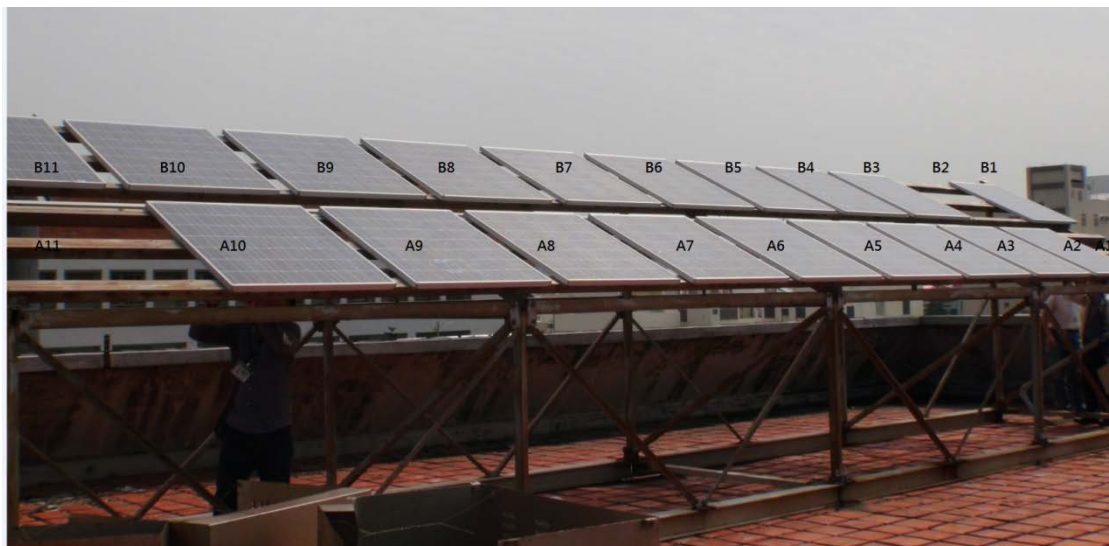
Figure 1.3.2.5.1 Module number and relative position in the PV system

No.	appearance	surface	encapsulation	connection	and Diode	frame appearance
A2	A* (very good)	Smooth surface Very good	Good connection without yellowing	Good connection	Diode burned out	C*
A3	4 corners defect (good)	Smooth surface Very good	Good connection without yellowing	Good connection	good	C*
A4	Upper corner defect (good)	Smooth surface Very good	Good connection without yellowing	Good connection	good	C*
A5	A* (very good)	Smooth surface Very good	Good connection without yellowing	Good connection	Diode burned out	C*
A6	Upper corner defect (good)	Smooth surface Very good	Good connection without yellowing	Good connection	good	C*
A7	B*	Smooth surface Very good	Good connection without yellowing	Good connection	good	C*
A8	B*	Smooth surface Very good	Good connection without yellowing	Good connection	Diode burned out	C*
A9	B*	Smooth surface Very good	Good connection without yellowing	Good connection	Diode burned out	C*

B1	Upper corner defect (serious)	Smooth surface Very good	Good connection without yellowing	Good connection	Diode burned out	C*
B2	B*	Smooth surface Very good	Good connection without yellowing	Good connection	good	C*
B3	B*	Smooth surface Very good	Good connection without yellowing	Good connection	Diode burned out	C*
B4	B*	Smooth surface Very good	Good connection without yellowing	Good connection	Diode burned out	C*
B5	B*	Smooth surface Very good	Good connection without yellowing	Good connection	Diode burned out	C*
B6	Aluminum foil oxidation (good)	Smooth surface Very good	Good connection without yellowing	Good connection	Diode burned out	C*
B7	A* (very good)	Smooth surface Very good	Good connection without yellowing	Good connection	Diode burned out	C*
B8	B*	Smooth surface Very good	Good connection without yellowing	Good connection	Diode burned out	C*
B9	Upper corner defect (serious)	Smooth surface Very good	Good connection without yellowing	Good connection	good	C*

A*: welding repair between wider ribbon and long strip EVA & backsheets was used to strengthen the insulation of the module

C*: pre-drilled holes for screw lock had serious potential corrosion

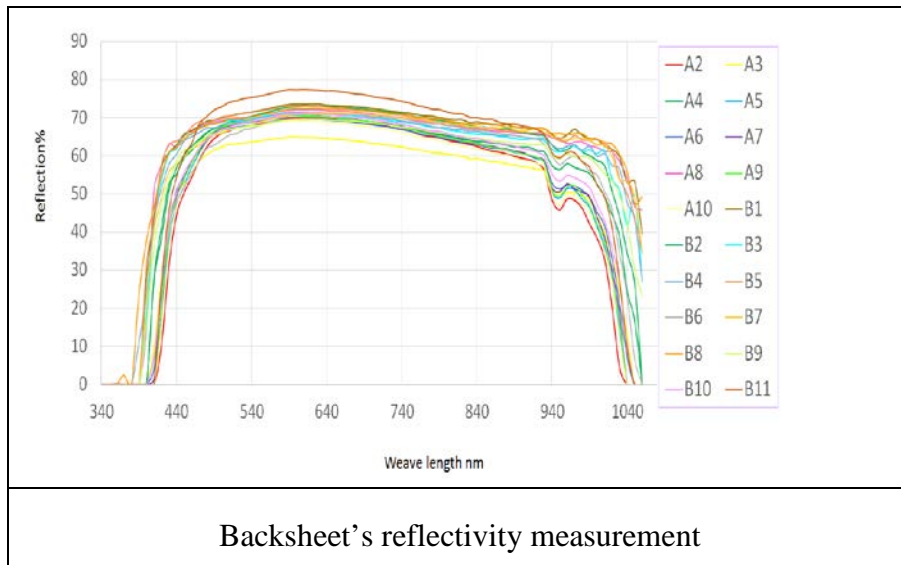
Figure 1.4.3.1 The Spectral characteristics detection of Penghu PV module

The main purpose for the spectral characteristics detection of the aging PV module was to know the aging status of the backsheet. Backsheet exposure in the sun and long term thermal cycle resulted in yellowing and aging phenomena after 17 years in operation. The aging modules still had around 65–75% reflectivity. Yellowing was not serious. It is mean that the quality of the backsheet materials is good.

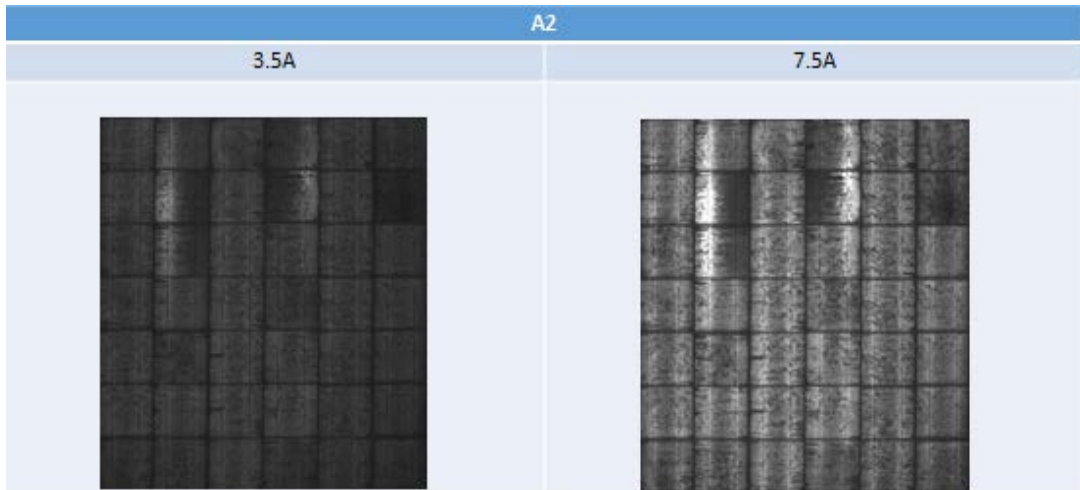
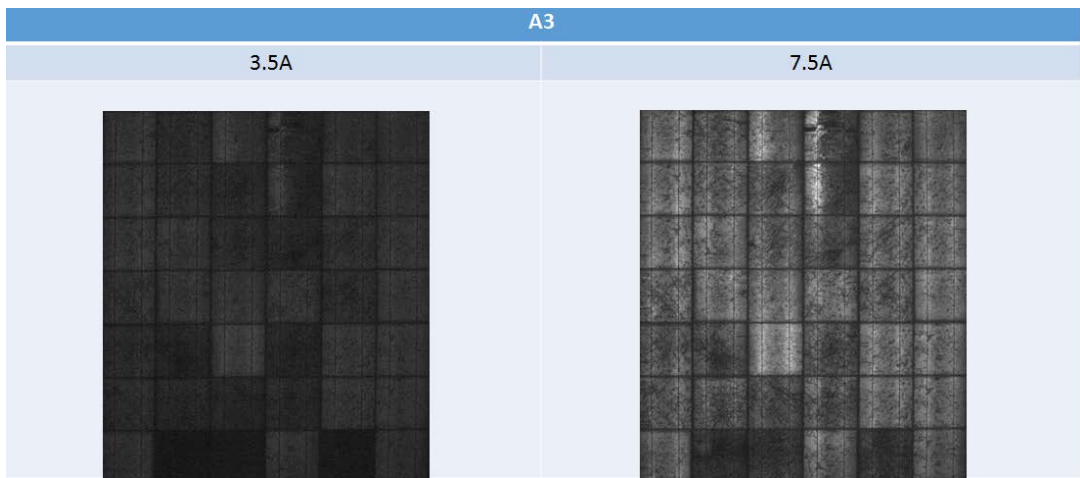
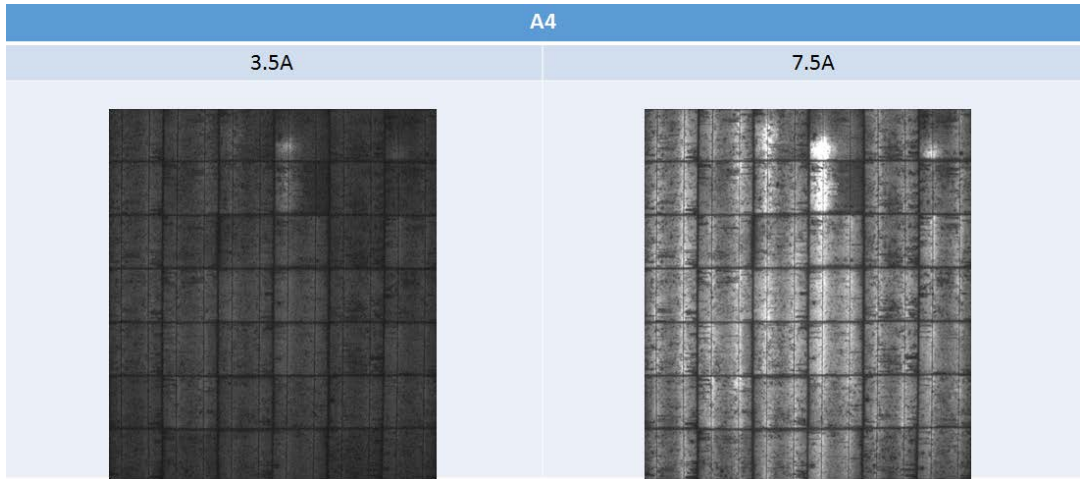
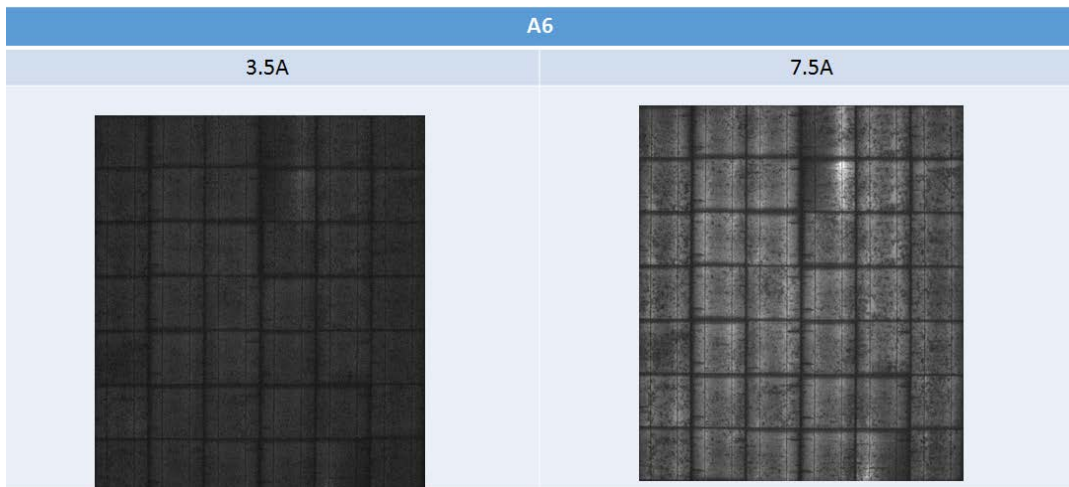
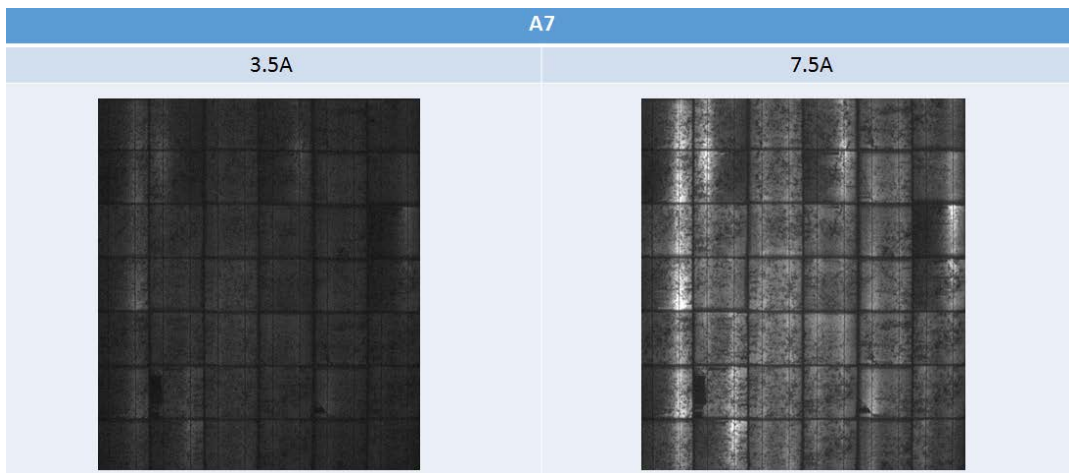
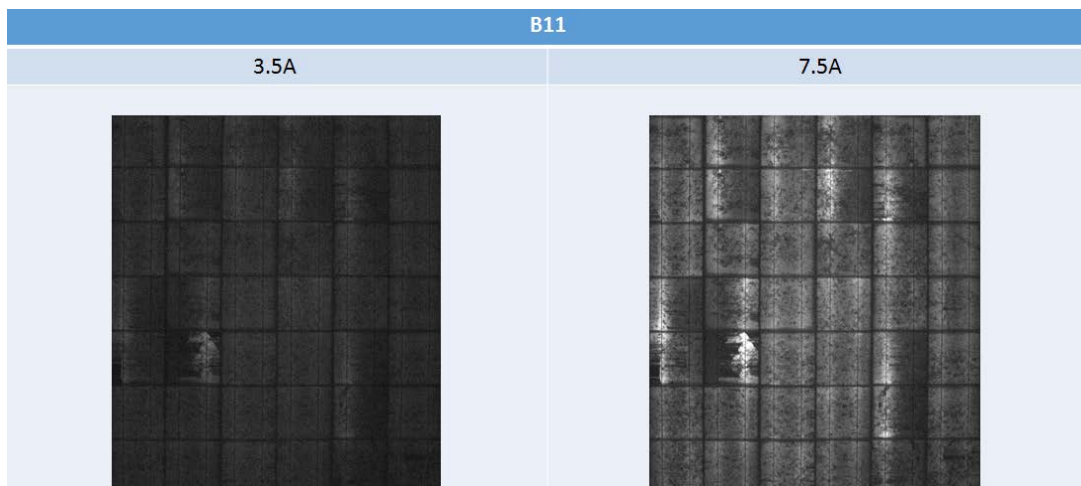
Figure 1.4.4.1 EL results of the Penghu PV modules

- Modules A7 and A9 had broken solar cells inside.

- Module A2: one of two Busbar had better conductivity, resulting in brighter EL picture (whiter in the picture).
- Module A3: some solar cell had poor power, resulting in darker EL picture (blacker in the picture).

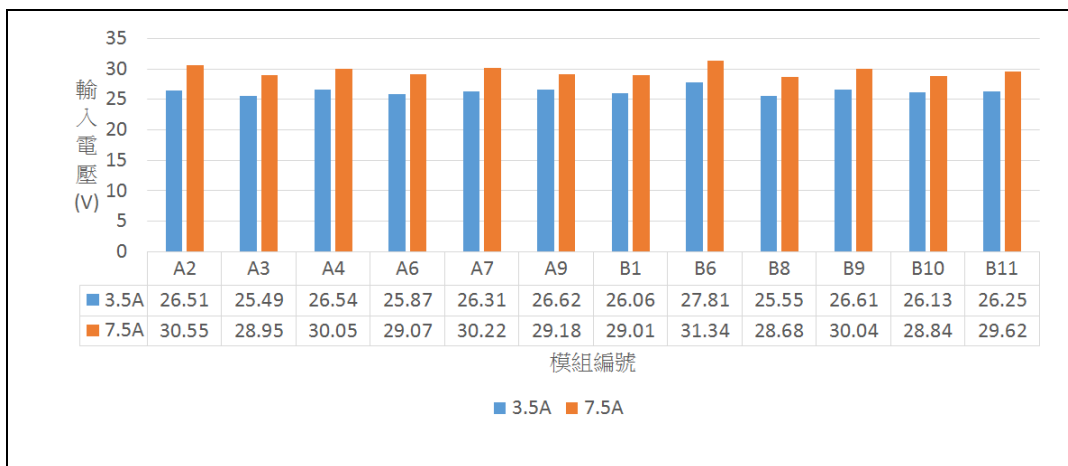
Figure 1.4.4.2 EL results of the Penghu PV modules-electric voltage relationship

Whenever EL used the same current to turn on the electric path, higher voltage means poorer module condition. Module B6 was typical of a module in poorer condition.

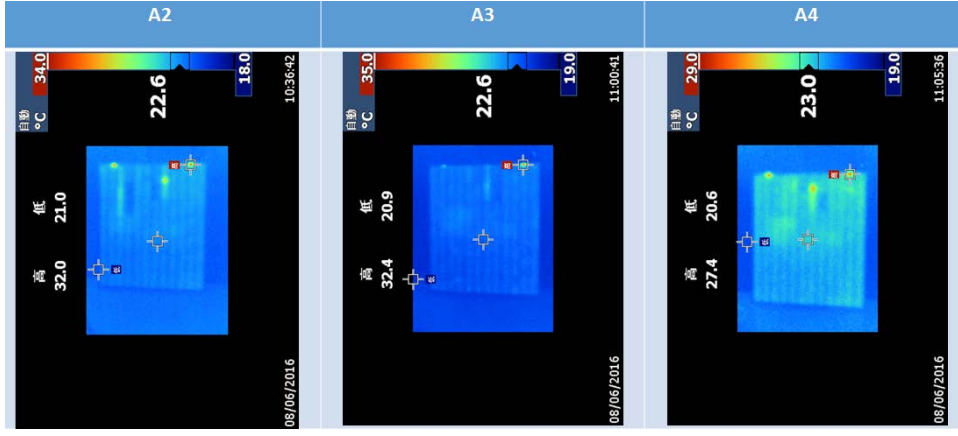
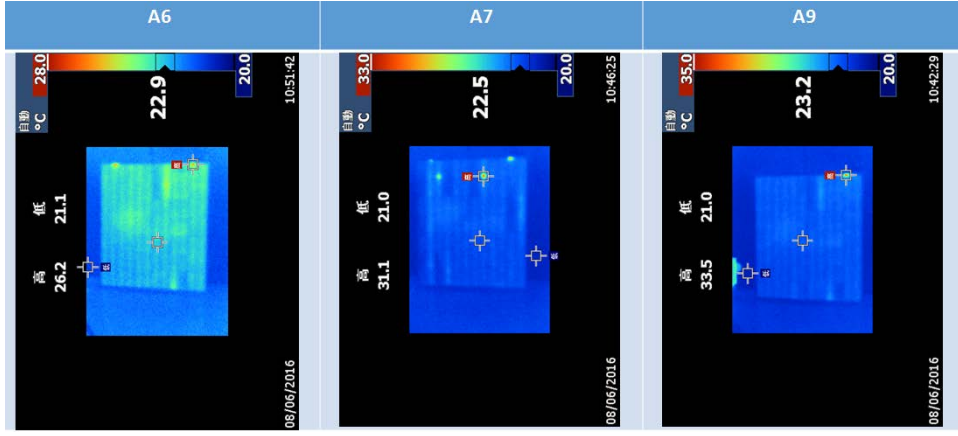
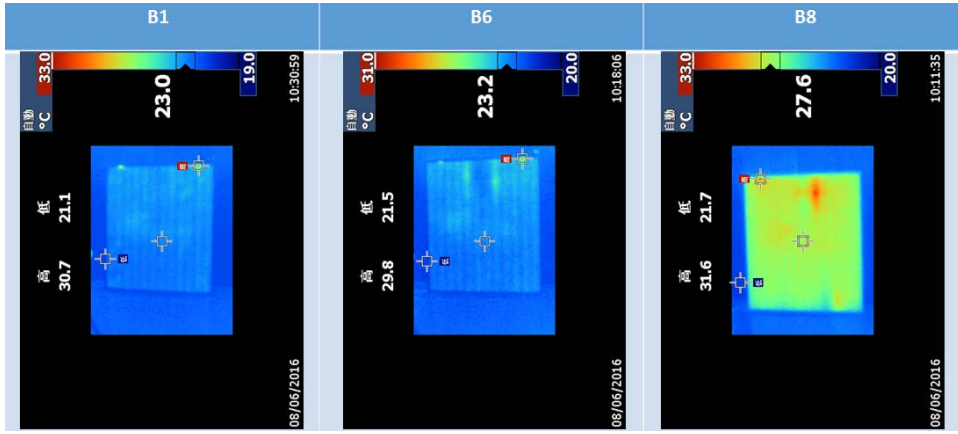
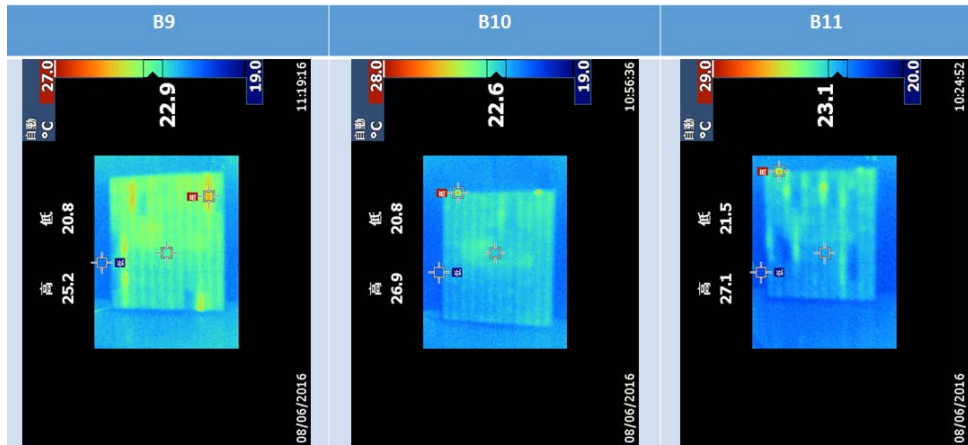
Figure 1.4.5.1 The Infrared thermal image of Penghu PV module

The main purpose for the infrared thermal image of the aging PV module is to find the hot spot of modules. The test results show that the highest temperature is 33.5°C. Because the frame is too close to solar cell, residual rain and dust may cause shedding and form the hot spot phenomena. Module A9 showed the highest temperature, 33.5°C, the root cause of this phenomenon is because the solar cell broke after comparison with EL results.

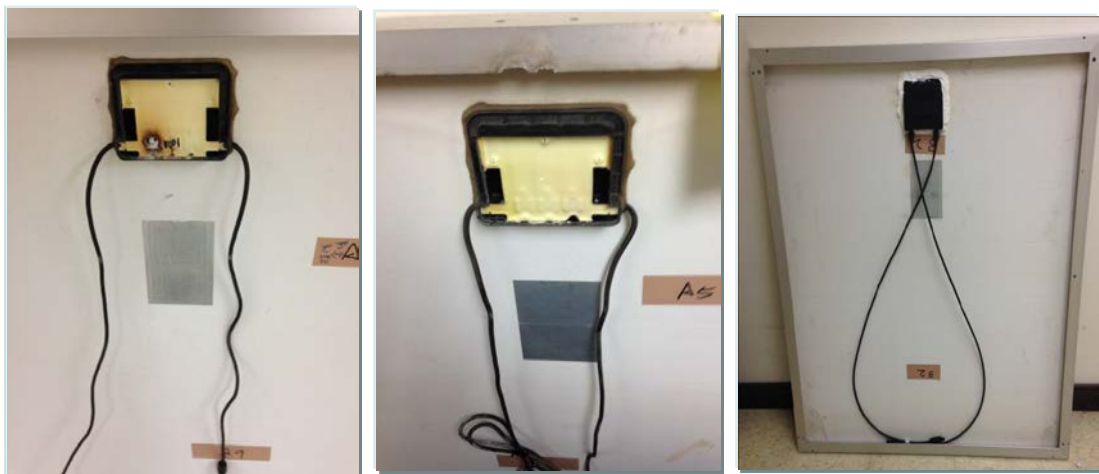
Figure 1.5.2.3.1 Junction box inside parts/structure

It is a necessary connection between wider ribbons due to the connection structure of the aging module. Tin/lead wire was used to reinforce the strength of the ribbon connection. Expansion caused by heat and contraction caused by cold is the root cause of the poor connection between wider ribbon. The chosen diode should pass the bypass diode thermal test of IEC61215ed.2.

Left: diode burn out; center: normal diode of aging module; right: replaced new junction box

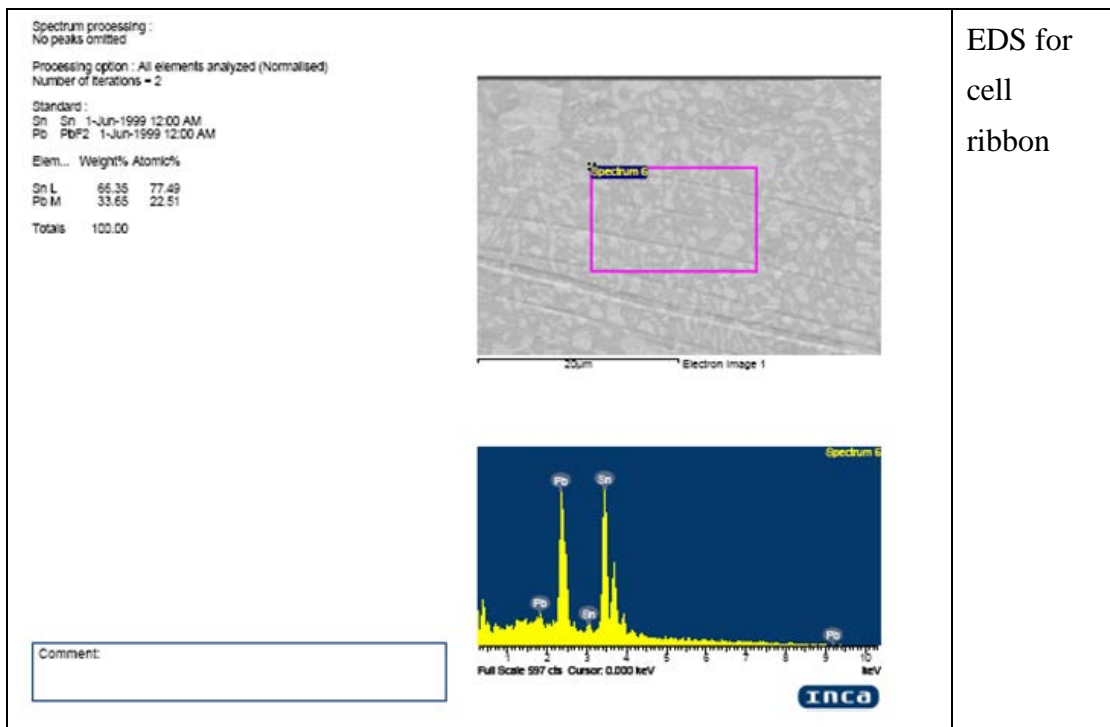
Figure 2.1.1.3 Element analysis of the used ribbon in the Penghu PV system

Energy Dispersive Spectrometer (EDS) in scanning electron microscope (SEM) was used to analyze the elements of used ribbon in the Penghu PV system. After EDS analysis, the tin/lead ratio is about 66/34 and 68/32 for thinner ribbon (connecting solar cell) and wider ribbon (connecting series cell and junction box) respectively.

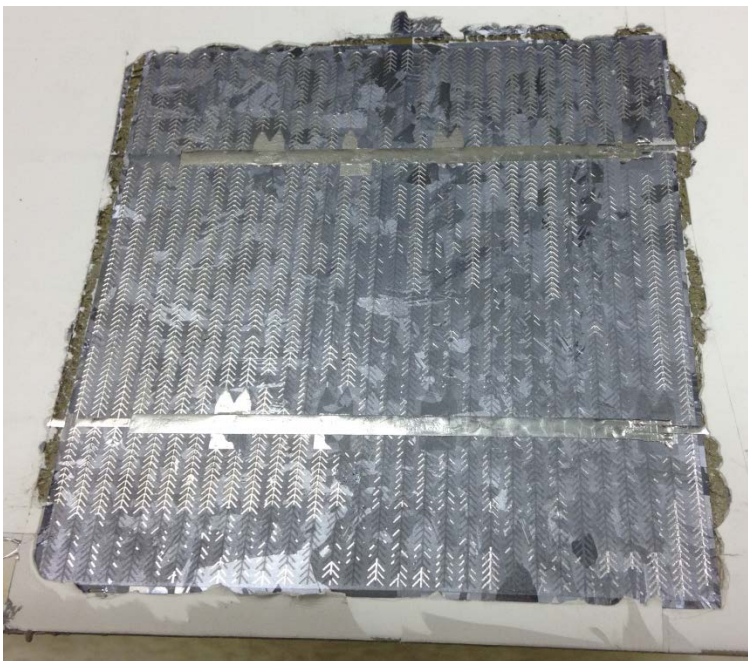
Figure 2.1.2.2 Finger in the back of module

Filler, typically white in color, is added into EVA for the application of solar cell back side encapsulation. Figure 2.1.2.2 shows leaf-shaped finger, which is especially designed. The figure is taken after removal of Backsheet and EVA. The fingers also do not see any “broken line” and corrosive phenomenon.

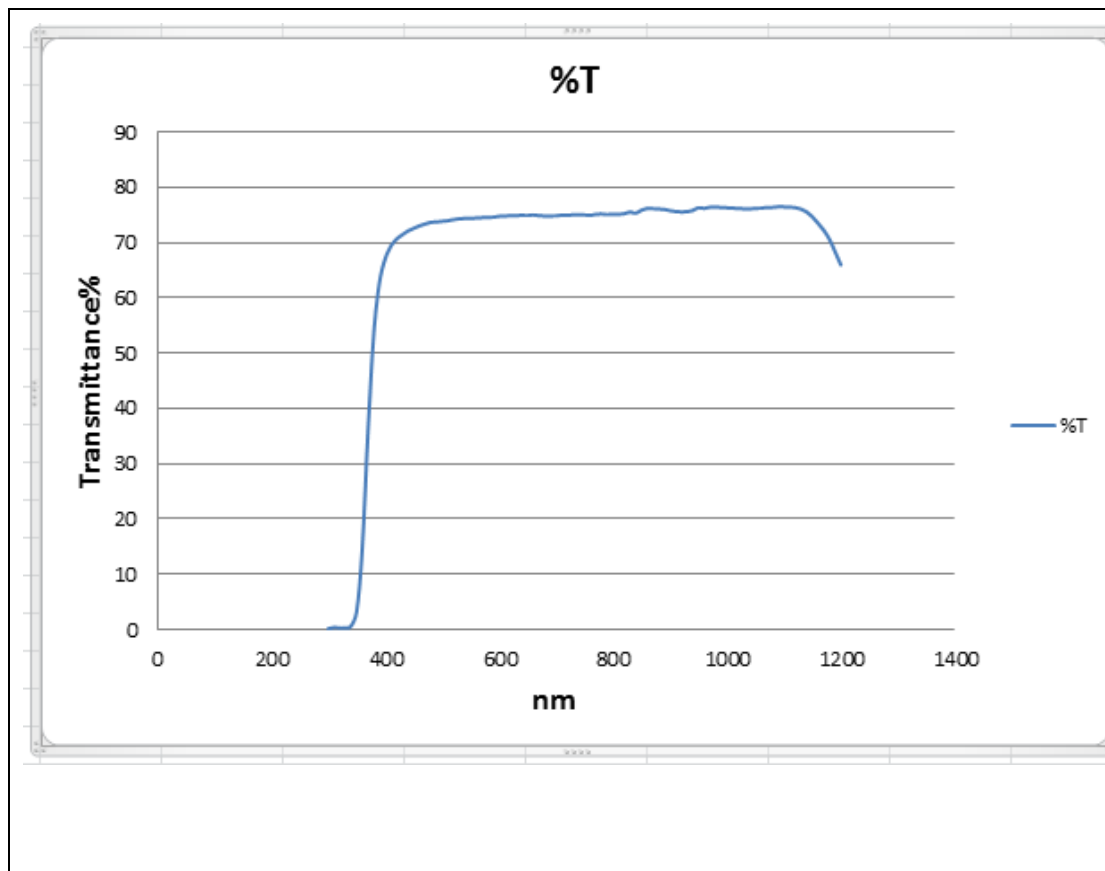
Figure 2.1.3.5 FTIR analysis-light transmittance of the top encapsulation film of the aging module

Figure 2.1.3.5 show that the light transmittance of the top EVA of the aging module is 75%. The value is far below the typical 88–90% for brand new EVA. The value indicates that the EVA in the aging module has aging phenomenon without yellowing. The bottom EVA of the aging module is still white. It means that the added filler, titanium dioxide, is still good after operating for 17 years in Penghu Islands.

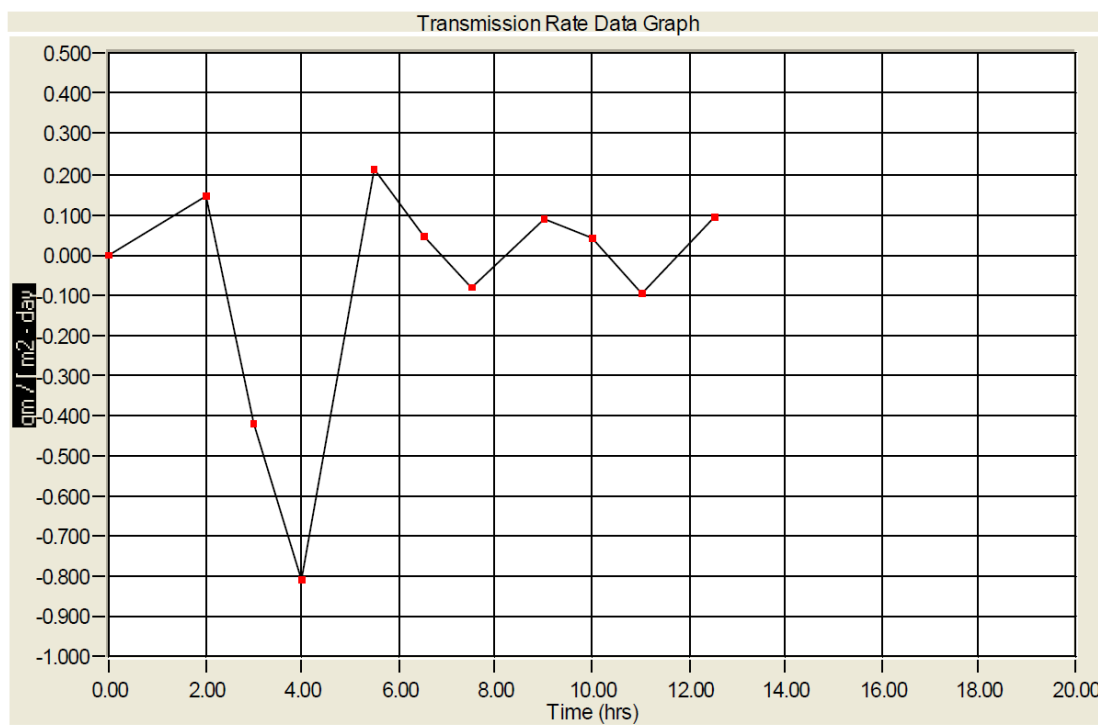
Figure 2.1.4.5 Aging module WVTR testing results

The aging backsheet (taken from Penghu’s PV system) has a four-layer structure. After FTIR analysis, it is confirmed that PVF (Polyvinyl fluoride) film from DuPont was used. The structures from inner to outer layers are PVF (Polyvinyl fluoride)/PET/aluminum film/ PVF (Polyvinyl fluoride). It is well known that PVF has good UV resistance and enhances module service life. Backsheet with aluminum film has low WVTR (water vapor transmission rate) value. Low WVTR module is helpful in guarding against water penetration into module, increasing module service life, according to ASTM F1249 standard test method for water vapor transmission rate through plastic film and sheeting using a modulated infrared sensor. Figure 2.1.4.5 shows the WVTR testing results.

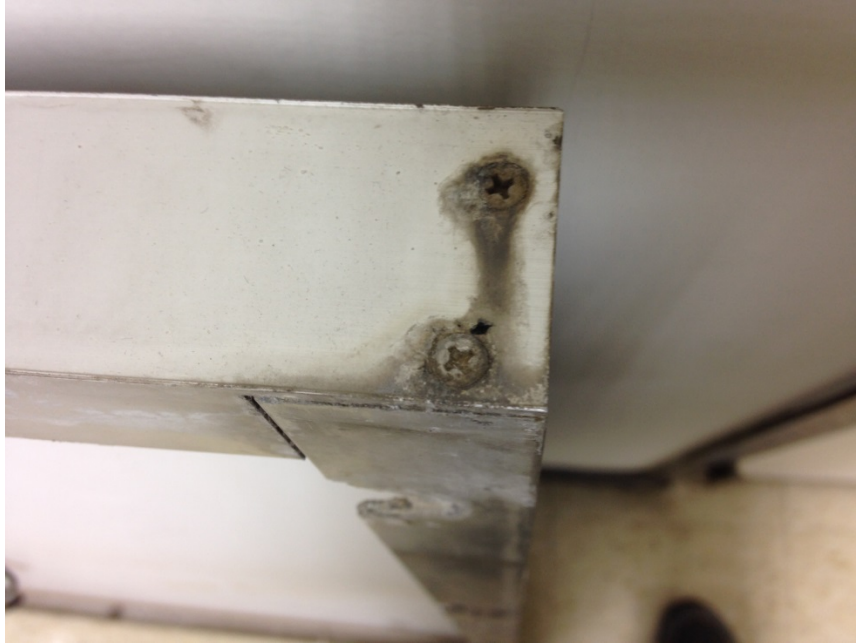
Figure 2.1.5.1.1 Aging module is assembled by screw

The 10–175 W modules are middle/small size modules produced before 2004. Typically, the module was assembled/screwed by hand. Due to the need of bigger modules in the PV market, manufacturers were able to produce 180–310 W modules starting at the beginning of 2005. The assembling of long and short aluminum frame is replaced by L-type key to avoid low quality hand screwing process. The aging module was produced by hand screwing. There are no defects, such as stripping or decomposition. It is evidence that the quality of the module is very good even after 17 years in operation. Figure 2.1.5.1.1 shows the assembled out-looking of the aging module.

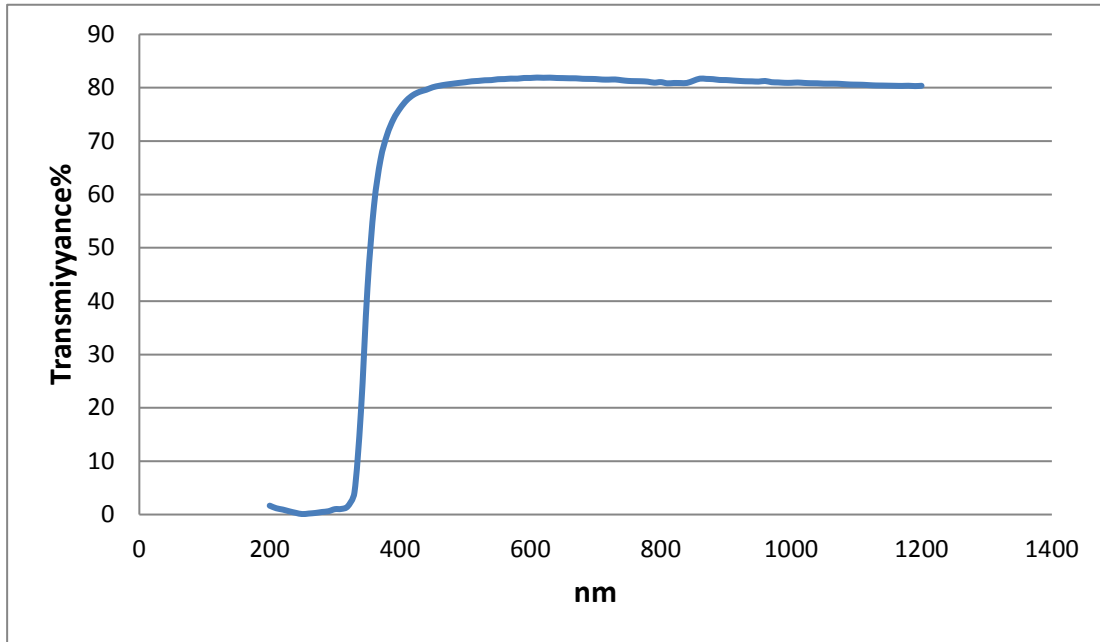
Figure 2.1.6.1 light transmission of aging glass

Typically, PV modules use low iron and light transmission tempered glass. The thickness of glass depends on the structure design. Light transmission affects the efficiency of PV module. Since iron content in glass results in green color of glass, PV module therefore use low iron glass. Glass not only offers module strength but also offers protection and wear-resistance. The glass on the aging module did not show any broken phenomena. There is only one module that fell to the ground due to corrosion of the aluminum frame. It is no related to the strength of glass. It is concluded that the strength of the glass used in the aging modules met the requisitions. The thickness of aging module is 3.2 mm. Figure 2.1.6.1 shows that the light transmission of the glass is only 81%, after having operated in Penghu. The typical light transmission of commercial anti-reflective glass, used in the PV module, is above 91%.

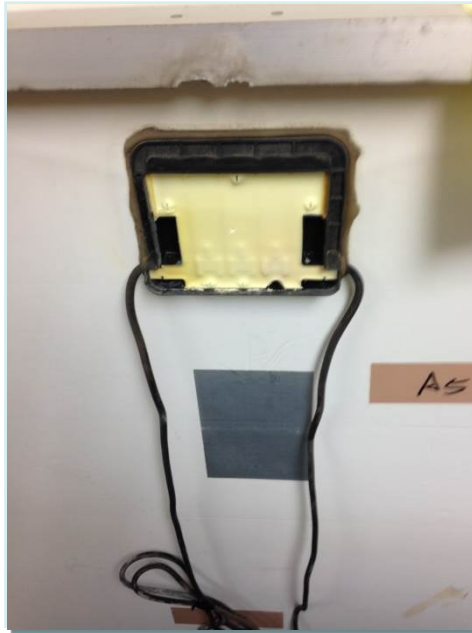
Figure 2.1.7.1 Diode and polymeric materials status inside the box

The structure and materials in the aging junction boxes are in good conditions after 17 years operation in the harsh environment. Polymeric materials were used to fill in the junction box. It is beneficial to guard against high humidity and high salt environment operation, keeping metal conductivity elements from corrosion. Figure 2.1.7.1 shows the diode and polymeric materials status inside the box. Figures 2.1.7.2 and 2.1.7.3 show the FTIR analysis of the polymeric materials. After Library search, the material is dimethyl siloxane. It is a silicon rubber type material with hard and brittle properties. Since the rubber is in good status, it is suspected that thermal conductivity materials were added into the rubber. The main failure mode for the aging junction boxes is diode burn out/peel off. It is suspected that the soldering point of ribbon was not treated very well. The local high temperature results in diode burn out/peel off because two of three burn out/peel off diodes were located at the edge of the box, near the soldering point of ribbon. The statistic of diodes status is listed in table 2.1.7.1. Figure 2.1.7.4 shows FTIR analysis and after Library search to find the material of the cover of junction box. It is confirmed that the material is PPO type materials. Figure 2.1.7.5 shows FTIR analysis and after Library search to find the material of the cover of cable connector. It is confirmed that the material is polyamide type materials.

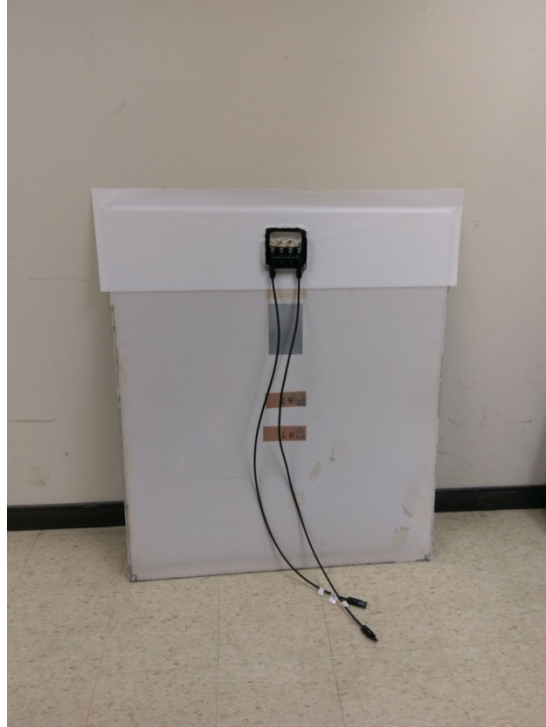
Figure 3.1.1.1 Laminate new EVA and Backsheet and install new junction box

The wider ribbon connection is not in good contact condition, due to the wider ribbon connection without applying tin-lead alloy to protect/strengthen the contact. The poorer contact results in arcing, which creates high temperature in the contact. The contact high temperature results in the delaminated and bubble phenomena between backsheet and EVA. It is found that some modules had only 50% module power left. The worst one or two modules do not have power output. The modules therefore needed maintenance. The maintenance procedures were:

- Cut off the delaminated backsheet and EVA
- Applying tin-lead alloy to strengthen the connection of wider ribbon-completed connection
- Laminate new EVA and backsheet (figure 3.1.1.1)
- Trim off redundant EVA and backsheet at module edge and install new junction box
- If the restructuring module passes IEC61215ed.2 wet leakage current test, the modules are qualified to be used.
- Power test needs to be above 80% of the original specification
- Install new aluminum frame

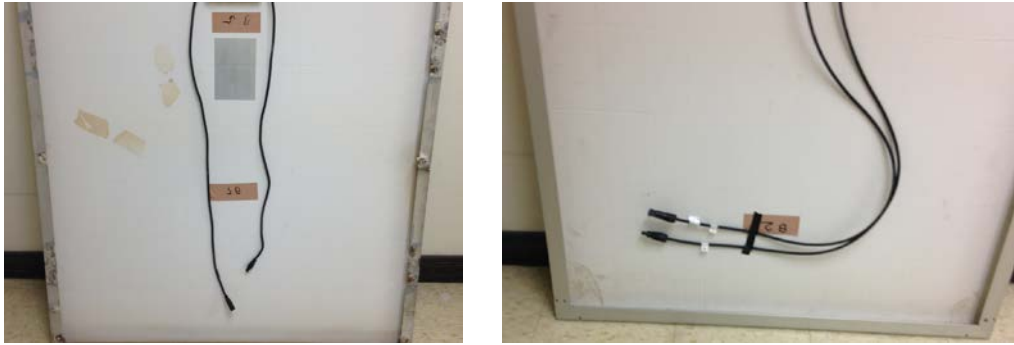
Figure 3.1.2.1 The connector replacement

Tyco junction boxes were used to replace the existing junction boxes because diodes were burned out after long periods of operation in the harsh environment. Also, the metal elements inside the junction box's connector showed atmospheric corrosion. Since connectors connect modules, the electric properties needed to match each other. For these two reasons, the junction box had to be replaced by new Tyco junction boxes.

Left: before replacement; right: after replacement

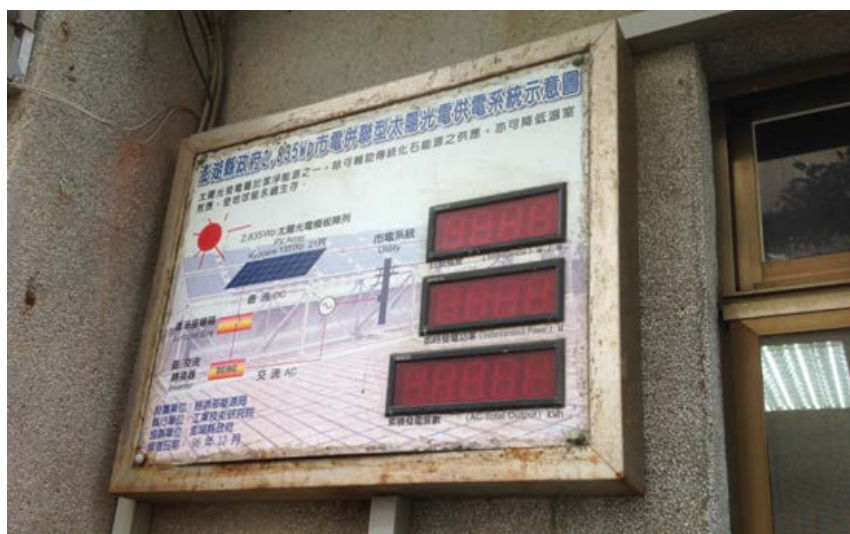
Figure 4.1.1 The monitor display of the Penghu PV system

1. The cable connection points inside monitor display with corrosive phenomena. The LED display did not function.
2. AC/DC power panel was protected by the monitor box. The parts were still working and could be used.
3. Inverter was not working. The paint on the inverter surface had corroded. Cooling fan was stuck and could not rotate. The cable still could be used. The soldering point and connector of PCB showed aging phenomena.

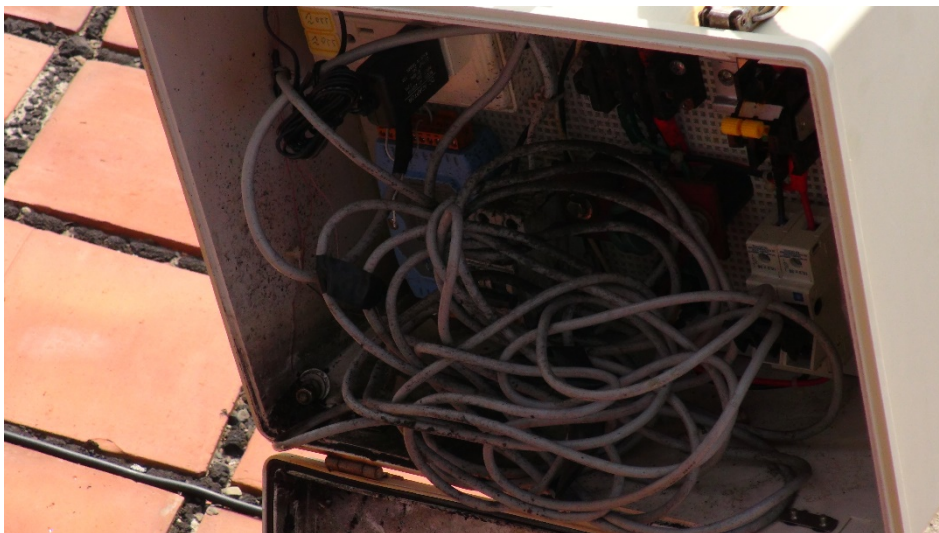
Figure 4.1.4 The monitor box

4. Because DC combiner box and DC combiner box were installed on the side of the rooftop array bracket, the connector of cable, which was near the interface of inner and outside monitor box, started corroding under harsh environment. The monitor box had fallen down because the corrosion of the screws, which were used to fixed the box. Rain, therefore, enter the monitor box and the damaged the parts.
